Technical Report HL-96-22
December 1996

Demonstration Erosion Control Project Monitoring Program

Fiscal Year 1994 Report

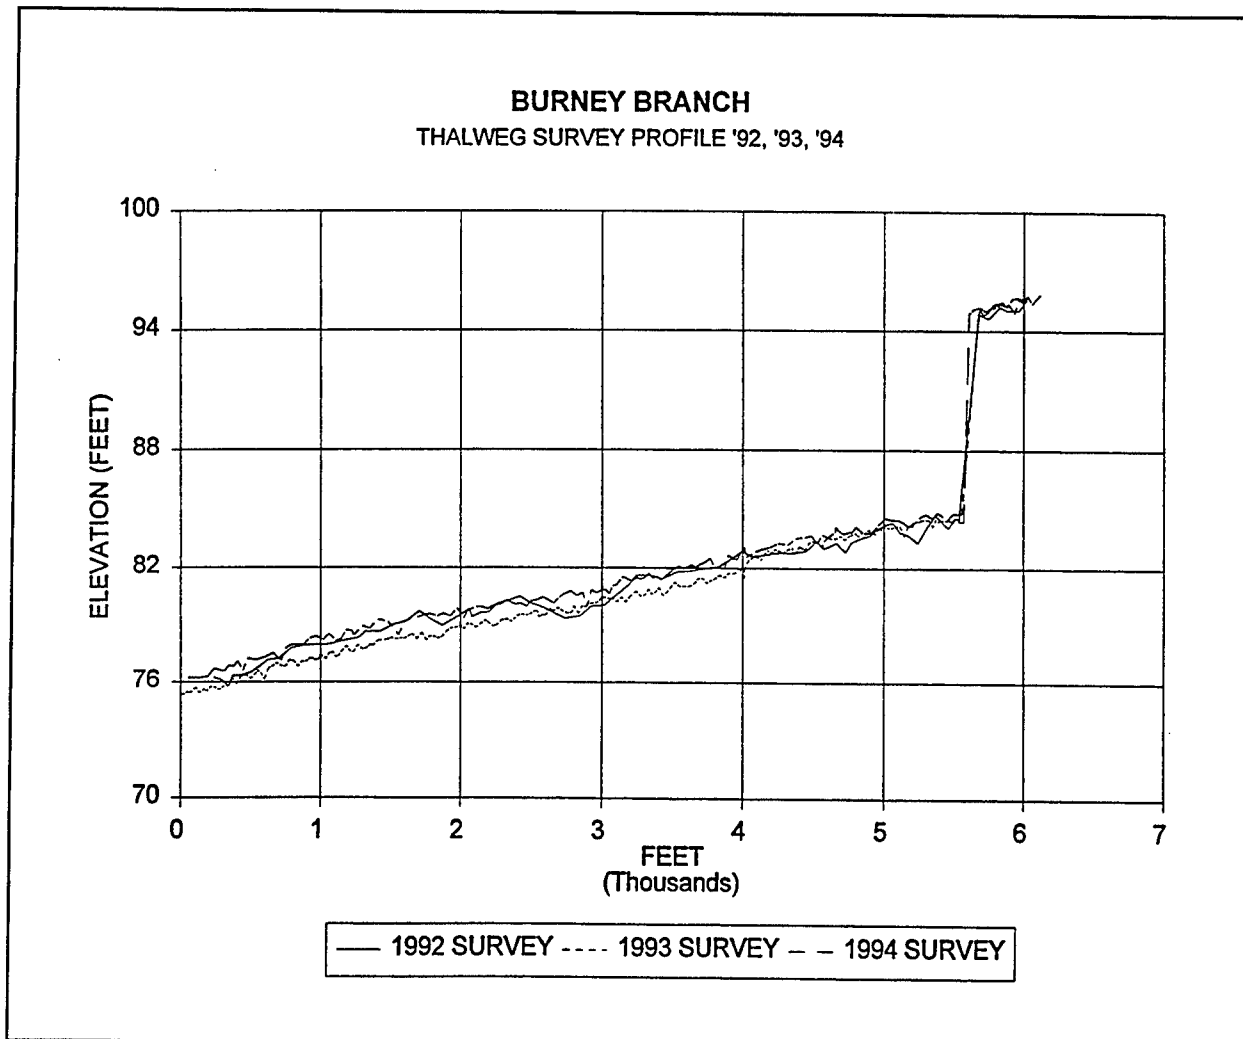
Figure 15. Burney Branch, Site 12, thalweg profile

As shown in the accompanying thalweg profile (Figure 15), Burney Branch is relatively stable with only minor fluctuations in the bed profile. The two high-drop structures have a significant impact on the reach. BURBANK analyses indicate that only a minor portion of the lower reach is at risk of failure. SAM analyses indicate that the segments at this site are within

7 percent in width and depth of the minimum stream power channel for transport of 1,000 mg/l (Table 9). The Burney Branch site is an excellent example of channel stabilization, and demonstrates the utility of SAM minimum stream power computations in assessing stability.

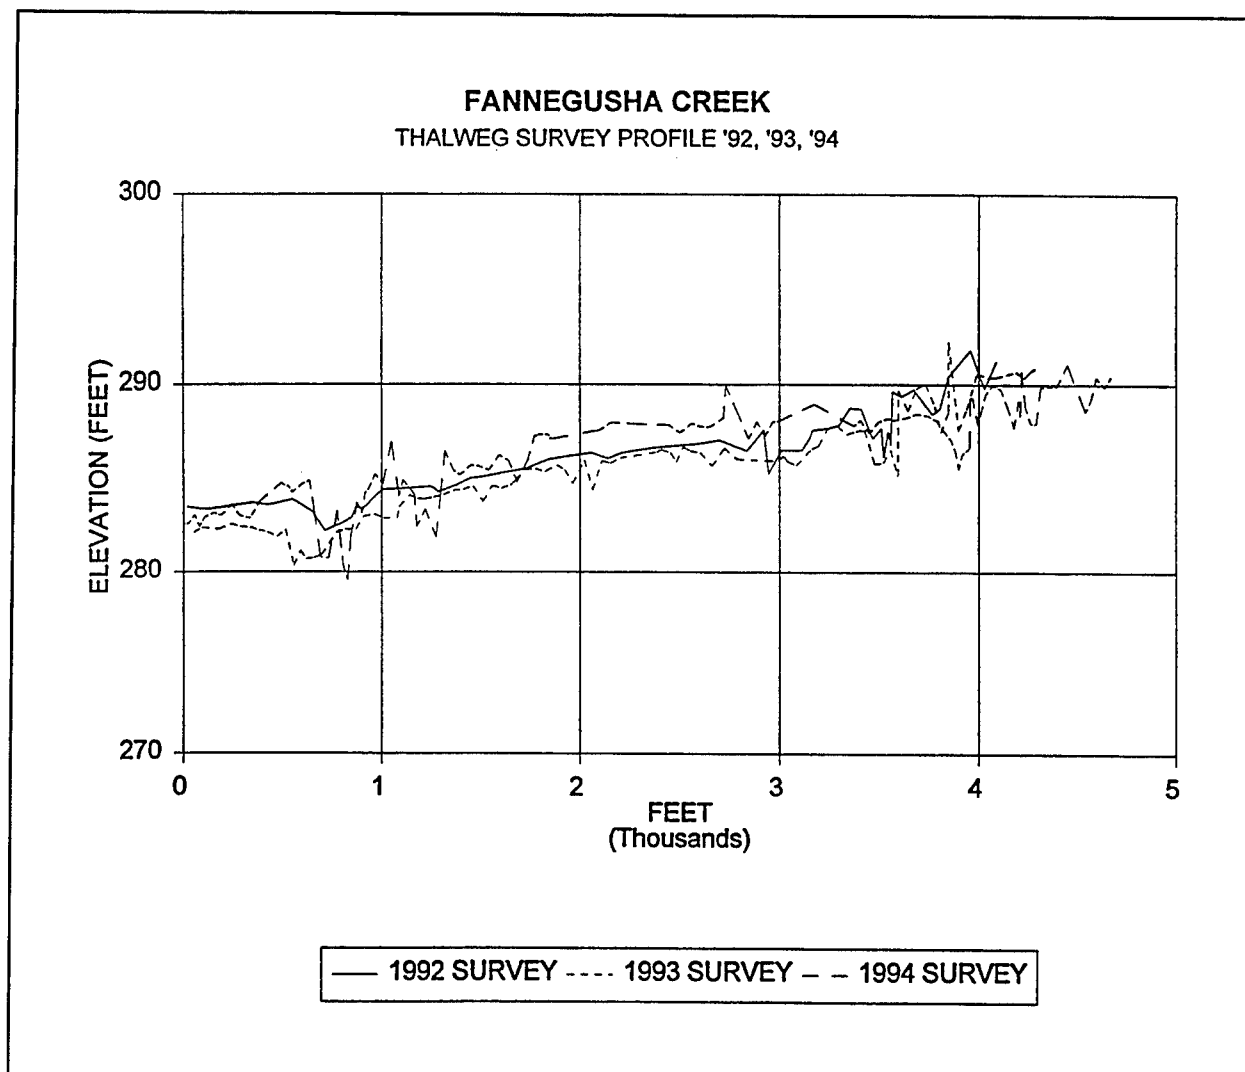
Figure 17. Fannegusha Creek, Site 2, thalweg profile

As shown on the accompanying thalweg profile (Figure 17), the Fannegusha Creek study reach is very active. The lower 1,000 ft of the reach degraded between 1992 and 1993. An ARS low-drop structure was constructed between the 1993 and 1994 surveys approximately at station 10+00. The 1994 thalweg profile indicates that degradation has occurred immediately downstream of the structure, and that a significant amount of aggradation has occurred from about 300 ft upstream of the structure to approximate station 33+00. Therefore, the new structure seems to be functioning well; however, continued surveys will better define the extent of degradation upstream and downstream of the structure. The lower 600 ft of the reach is in very resistant clay, and old,

rotational failures were observed along top bank. These failures gave no appearance of recent movement.

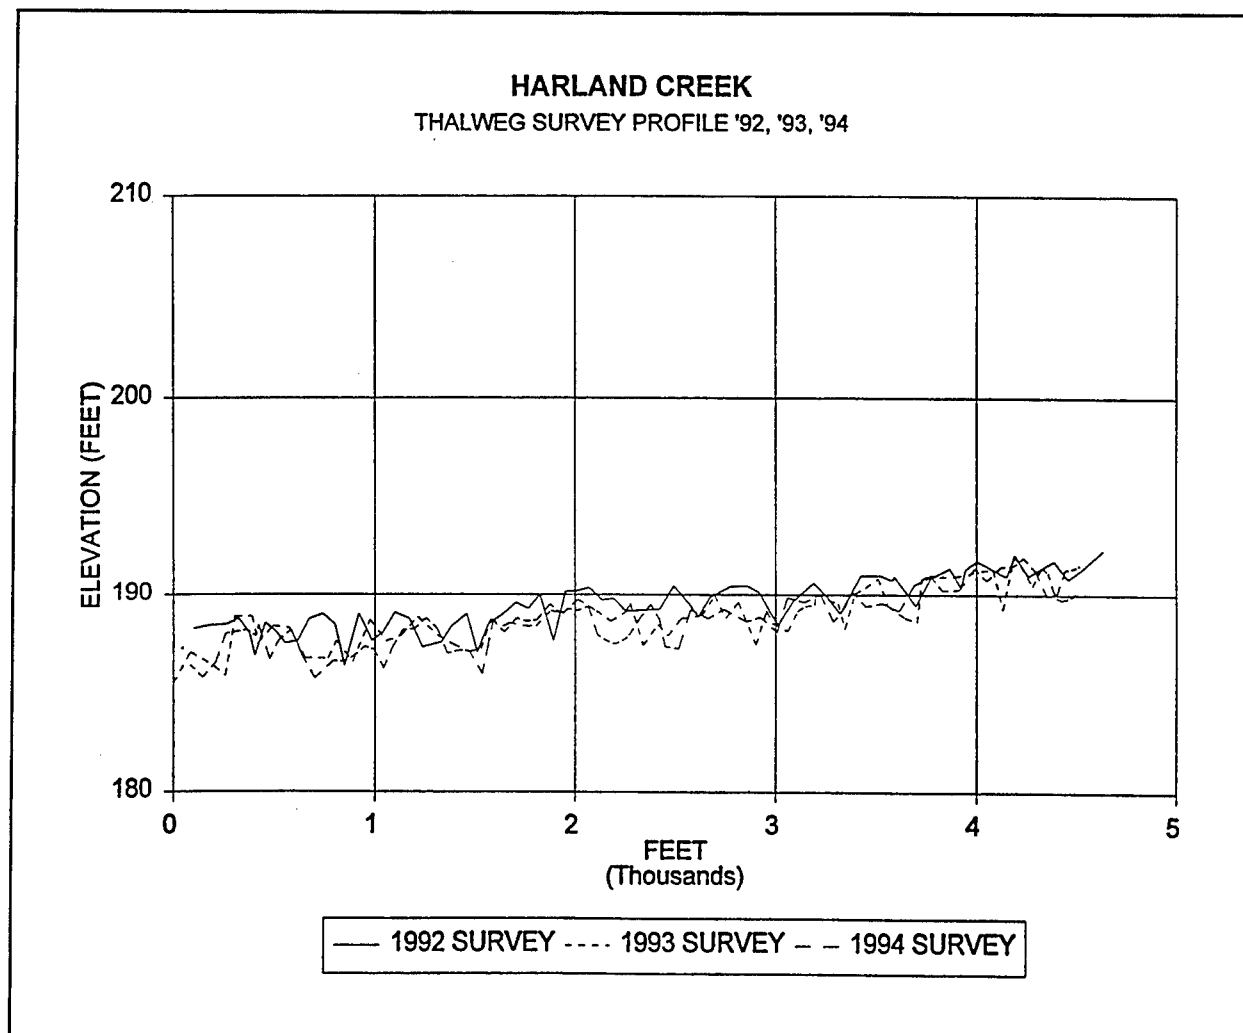
Figure 19. Harland Creek Site 1, thalweg profile

As shown in the thalweg profile comparison (Figure 19), the thalweg profile has fluctuated somewhat during 1992, 1993, and 1994. However, no significant changes in a system context are evident. In general, some slight deepening can be noted for 1994, and field evidence indicates that the riprap that was placed after the 1992 survey has resulted in greater water depth. After the June 1994 thalweg survey, thunderstorms during July through October 1994 resulted in severe bank erosion in the unprotected portion of the reach. Field inspection during October 1994 documented severe erosion on the right bank upstream and downstream of the longitudinal riprap at the bridge. Also noted in that field inspection was the low-water filling of the deep pools that had been observed immediately following the riprap placement.

Bank stability calculations indicate that the surveyed cross sections are stable (Table 11). The 2-year water surface slope of the reach is 81 percent, and the average stream width is 506 percent of the slope and width required at minimum stream power for transport of 1,000 mg/l. These dimensions generally indicate that the bank erosion is due to local hydraulic forces and that channel degradation should not be occurring unless the upstream sediment supply is significantly reduced.

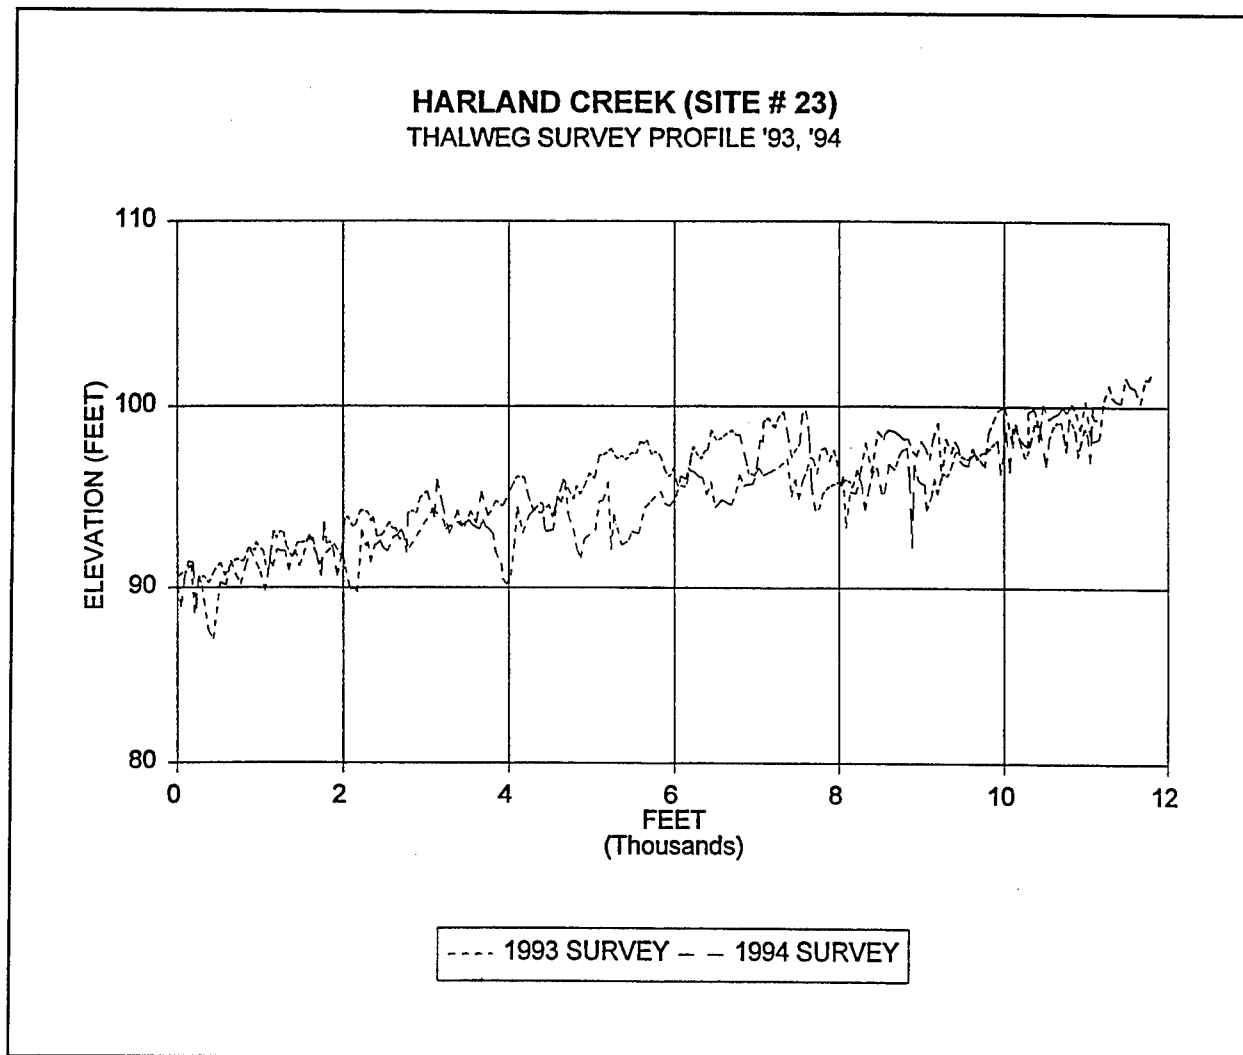
Figure 21. Harland Creek, Site 23, thalweg profile

As shown in the thalweg profile (Figure 21), the primary difference between the 1993 and 1994 profiles is the aggradation that has occurred from about station 35+00 upstream to approximate station 75+00. Large gravel bars were observed in the field inspection of October 1994. Some of these bars were in unusual positions for a meandering stream, indicating that the deposits occurred during the recession of a major flood event. It is expected that lower flows will continue to rework these deposits.

Bank stability calculations indicate that the surveyed cross sections are generally stable, with only 2 percent of the 1994 bank at risk (Table 12). The 2-year water surface slope of the reach is 116 percent, and the average stream

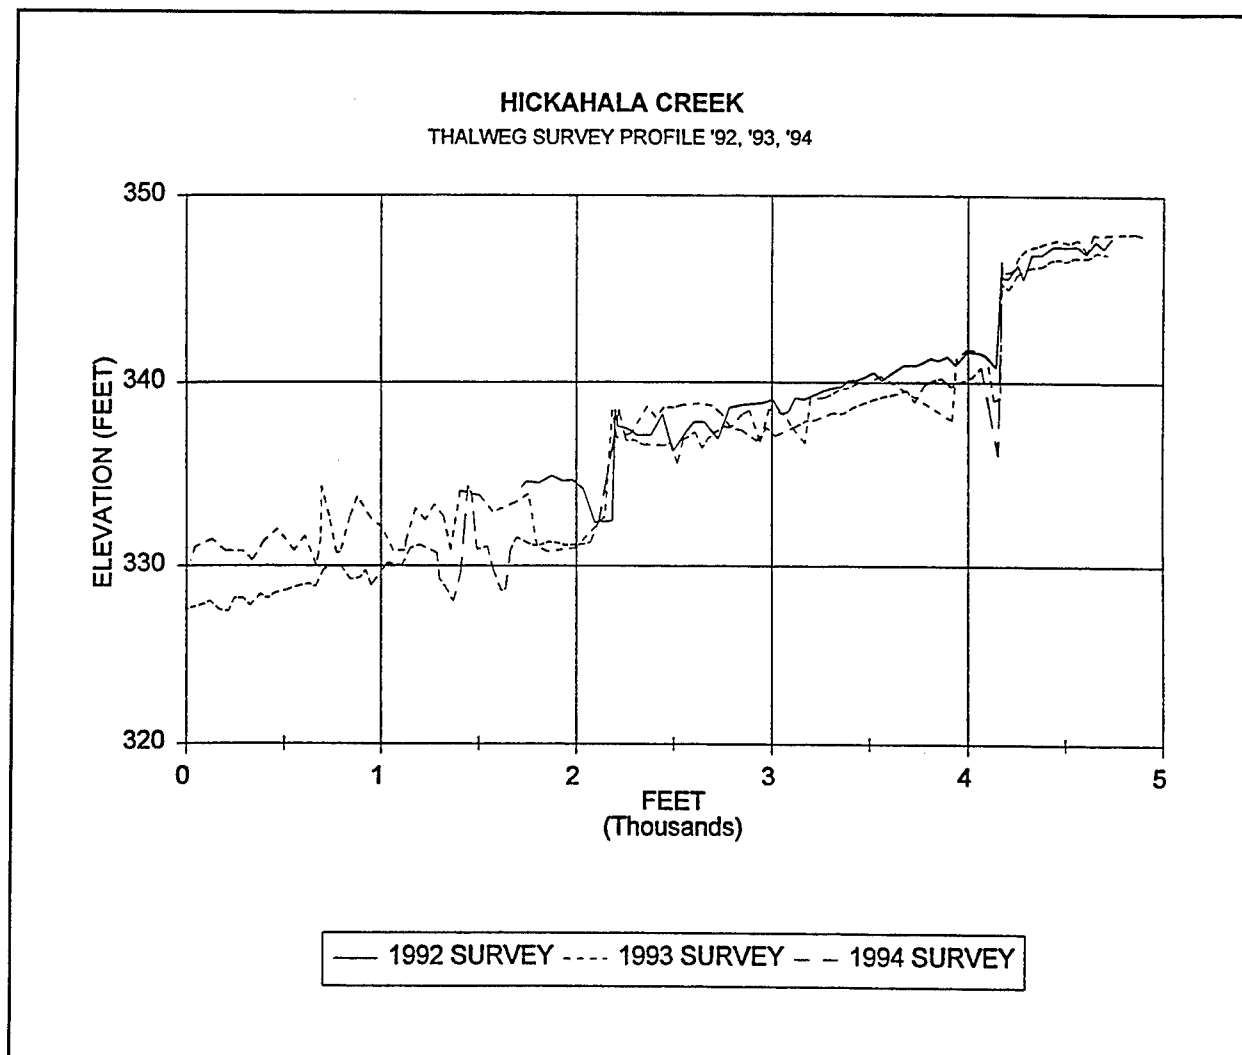
Figure 23. Hickahala Creek, Site 11, thalweg profile

Two low-drop structures are included in the study reach, and as shown in the accompanying thalweg profile (Figure 23), the downstream profile has been actively degrading. The upstream drop structure appears to have changed little during the last year, although some rock displacement upstream has occurred. The South Fork drop structure is a newer, grouted rock structure. Minor cracking of the grout was observed. A beaver dam, approximately 2 ft in height, has been built in the upstream approach riprap. The confluence of South Fork with Hickahala Creek is eroding badly, with high flows from Hickahala Creek now entering the tributary at a location about 150 ft upstream of the previous confluence. The confluence also has significant debris from fallen trees. The downstream structure on Hickahala Creek also has a beaver dam upstream of the structure. Water is ponded upstream, and local bank failures have occurred. This downstream structure is also a newer, grouted riprap structure. A significant crack, about 2 cm in width, exists along the left bank portion of the weir cap, between the grouted riprap and the concrete weir cap. Apparently, the grouted stone has rotated downstream to form this crack.

No similar feature was noted on the right bank. The channel is irregular downstream and a large headcut is located at approximate station 15+00.

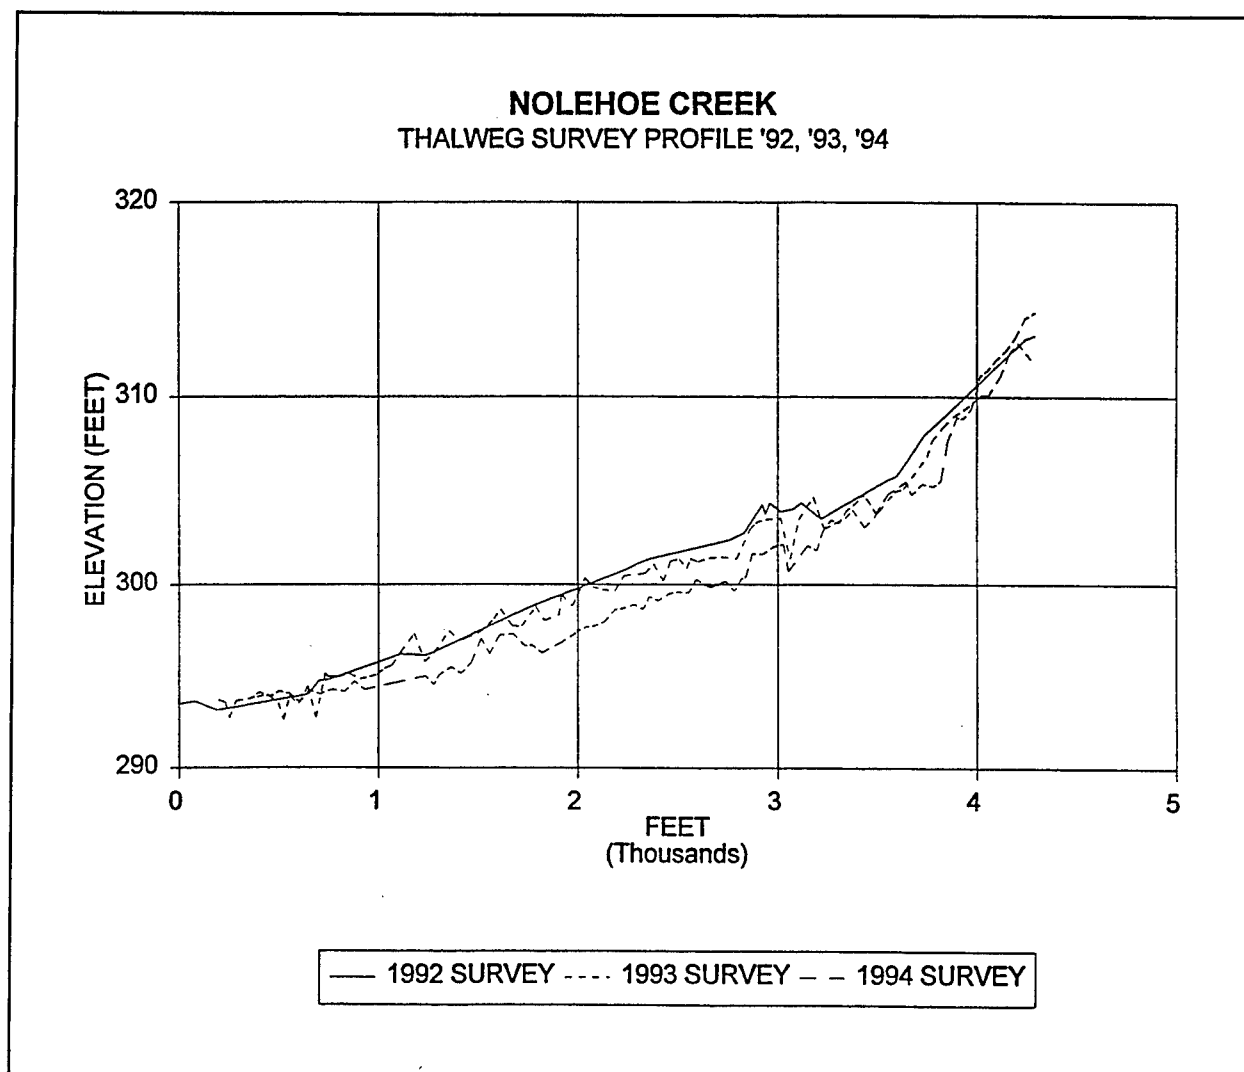
Figure 35. Nolehoe Creek, Site 7, thalweg profile

As shown in the accompanying thalweg profile (Figure 35), Nolehoe Creek has continued to degrade by approximately 4 ft between 1992 and 1994. During the November 1994 site visit, construction personnel were replacing the upstream box culvert apron and wing walls. Apparently the recent degradation has caused the need to reinforce the apron, and erosion at and around the road side of each wing wall was severe. In addition to the construction at the site, the highway that follows an east-west route approximately parallel to Nolehoe

Creek is in the process of being widened from a two-lane to a four-lane highway. Improvement adjacent to the highway includes better drainage, and the next upstream road crossing for Nolehoe Creek has been enlarged from a pipe culvert to a double concrete box. Residential development in the upstream watershed is continuing and the pattern of development is for commercial and office development along the four-lane highway. The downstream golf course and residential development portion of Nolehoe Creek has been staked, indicating that construction is planned. This portion of the creek is downstream of the study reach. Although no gauging or streamflow records are presently available, the changing land use suggests that discharges are increasing, and as the construction phase is completed, the urban land use pattern will supply less sediment in the future.

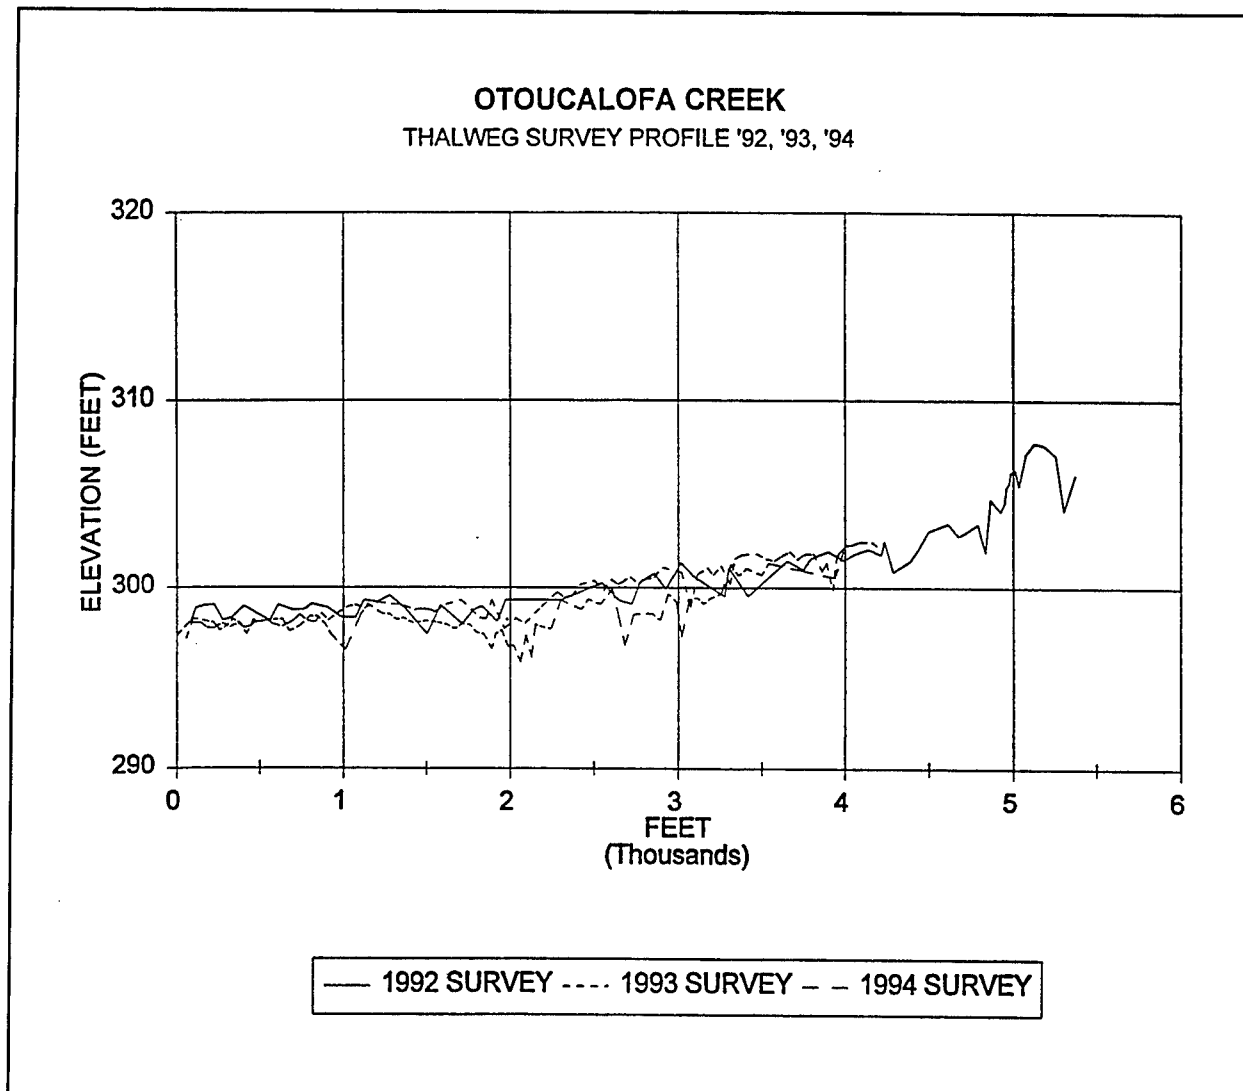
Figure 37. Otucafo Creek, Site 14, thalweg profile

As shown in the accompanying thalweg profile (Figure 37), Otocalofa Creek is degrading and a steep knick zone exists just beyond the upstream

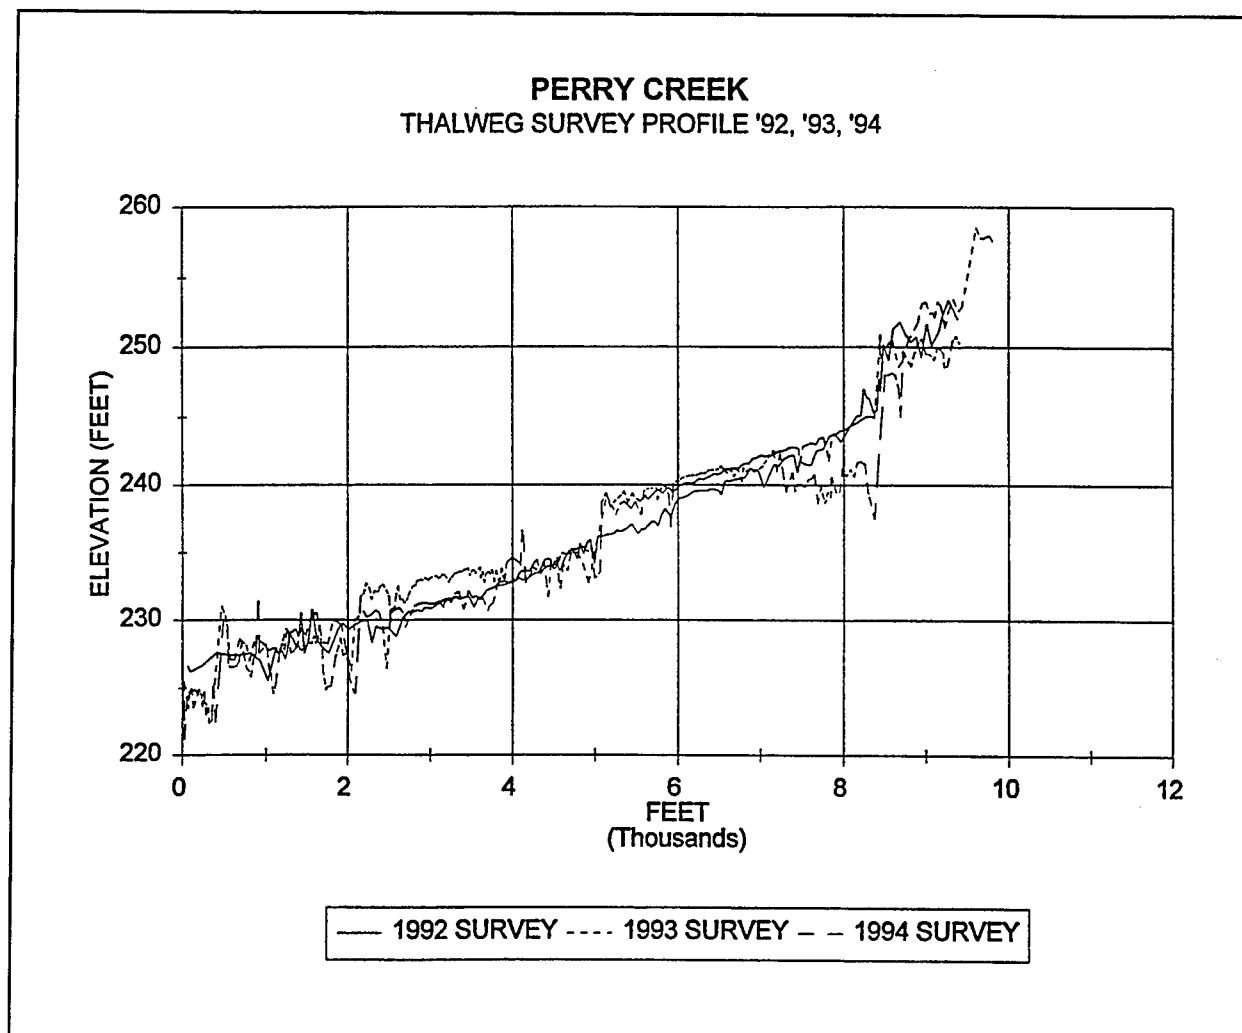
Figure 39. Perry Creek, Site 16, thalweg profile

The accompanying thalweg profile (Figure 39) shows the response to the construction of the four grade control structures. Surveys during the 1993 and 1994 period represent construction conditions. The four structures are located at approximate station 20+00, 50+00, 85+00, and 100+00. However,
